Plaintiff’s Expert Report and Affidavit

PRO-CUT, KG-32, MEAT GRINDER FAIL.

Khusenov v ProKraft & Pro-Cut

Dr Andy Foley P.E

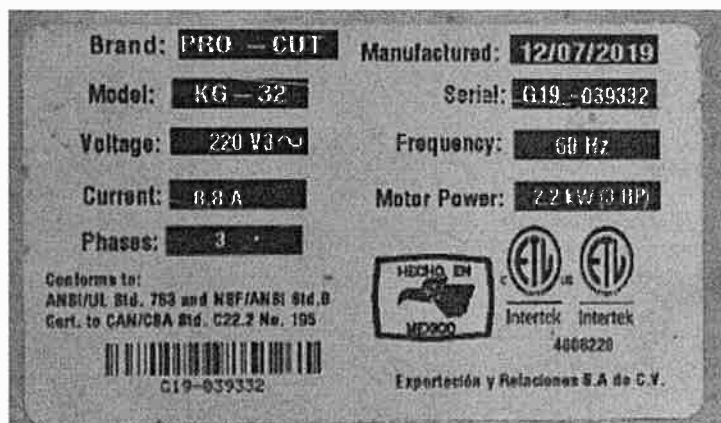
Figure 1. Machine Name Plate (From inspection photos 1/10/2022)

Figure 1. is a photograph of the machine make of this machine

Type / Model : PRO-CUT, KG-32

Serial No. : G19-039332

Year of Manufacture : 2019

Voltage : 220 (3 Phase)

KW/HP : 2.2/3

Amps : 8.8

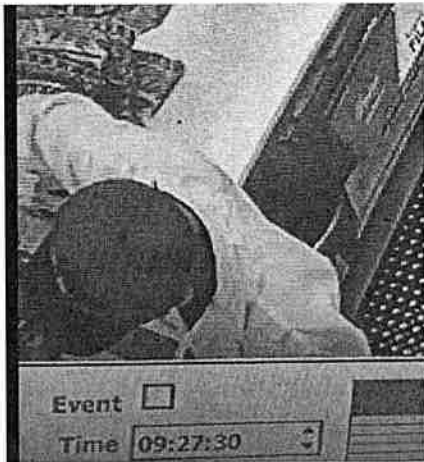
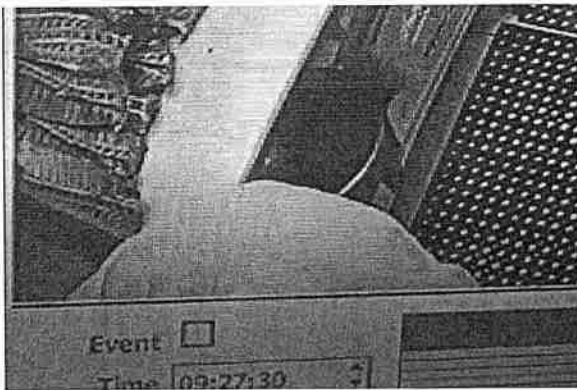
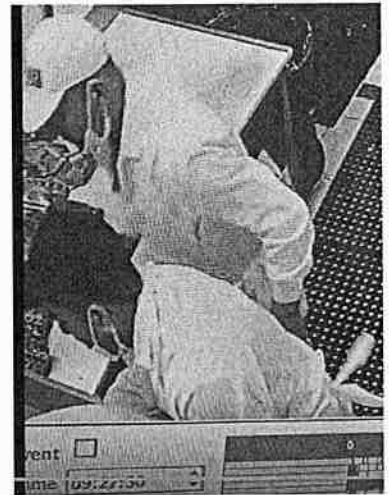
Figure 1. Video stills.

For the first 50 or so seconds Mr Kusenov appears to be pushing meat along the feed tray and into the grinder feed tube. He stops twice to reach down to what I believe would be the "ground" meat product collecting bucket/tray. I assume to adjust how the product is collecting in that bucket/tray. At around 54 seconds while feeding the meat products into the chute Mr Kusenov's head and upper torso suddenly drop out of the screen shot as his hand and arm are ingested into the grinder "worm" screw. Approximately six seconds later (1:00 on time elapsed) two coworkers run to Mr Khusenov's aid and one of them reaches over his body, presumably in an attempt to extricate him from the machine. Three seconds later, (1:03), and for approximately another 3 seconds this coworker appears to be trying to reach around the trapped Mr Khusenov and under the feed tray. This was either an attempt to press the machine's stop button and/or to start to disengage the grinder head from the rest of the machine. This same employee then reaches around the other side of Mr Khusenov and for a further 16 seconds supports the grinder head. Then at 01:21 Mr Khusenov and the two assisting employees can be seen moving with the feed tray and the grinder head unit to the other side of the shop whereupon the video ends at 01:49. During this time it is apparent that Mr Khusenov's hand and arm are still trapped inside the grinder head.

- 0:12 Mr Khusenov feeding meat product into grinder.*
- 0:55 Mr Khusenov's hand and arm ingested into grinder.*
- 1:02 Co-Workers reaching in front of Mr Khusenov to switch off machine and disengage grinder head.*

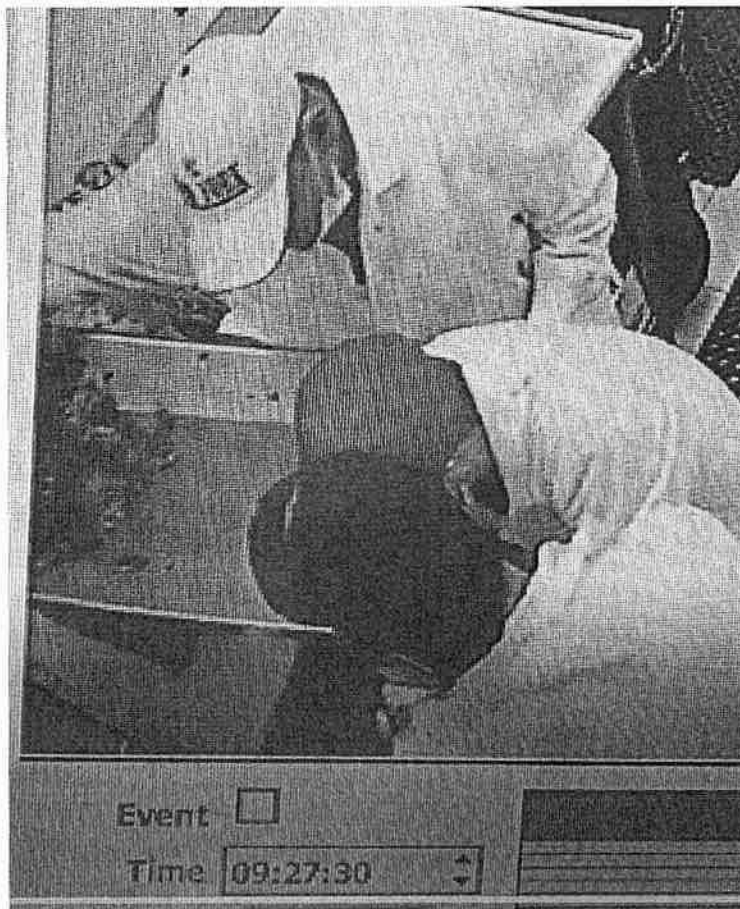
Figure 2. Video stills. 1:22 Mr Khusenov and Co Workers moving with grinder head and tray across the shop.
(From: DVD provided by Plaintiff's Attorney 12-6-2021)

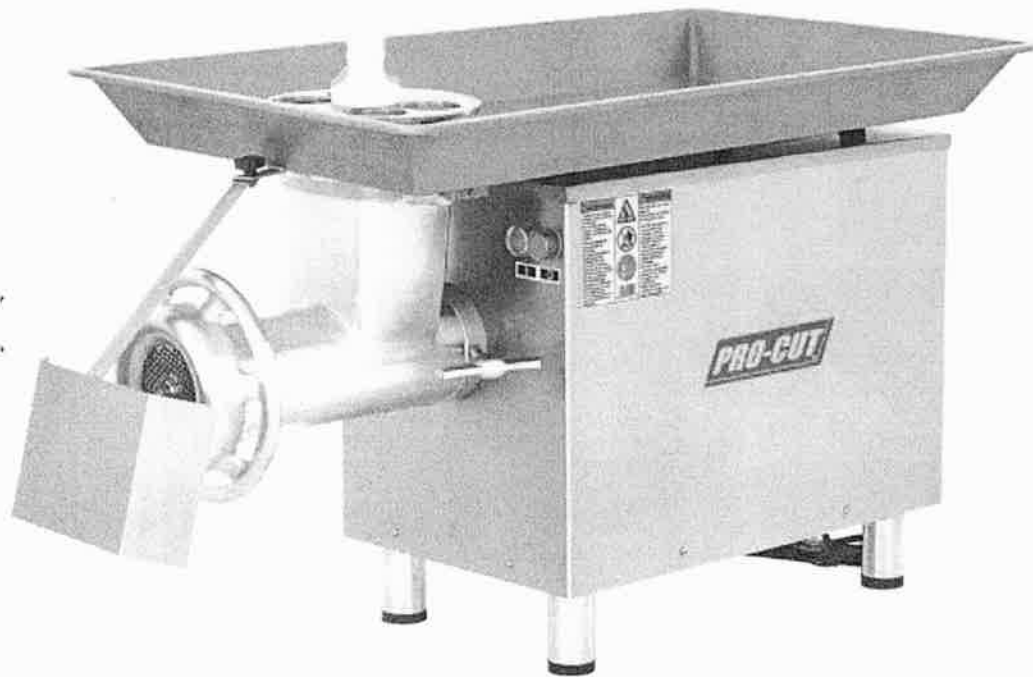
Figure 3. KG-32 Grinder.

The KG-32 is a heavy-duty meat grinder advertised as a breakdown, boneless meat grinder for use in butcher shops or other high-volume operations. Figure 3 is a photograph of the assembled machine copied from a supplier's web page.

The machine takes raw meat products onto its top mounted feed tray. The operator will then slide these products forward and into a down feed chute. At the bottom of this chute a "worm screw" will push the products horizontally into a rotating 4 bladed knife that cuts the meat before it is then squeezed through a plate full of 3/16 inch holes. The "ground" product then drops into a waiting bucket/tray. A deflector plate is also shown that is intended to guide the product into the waiting bucket/tray. (Note that the white plastic pusher is also present and inserted into the guard.

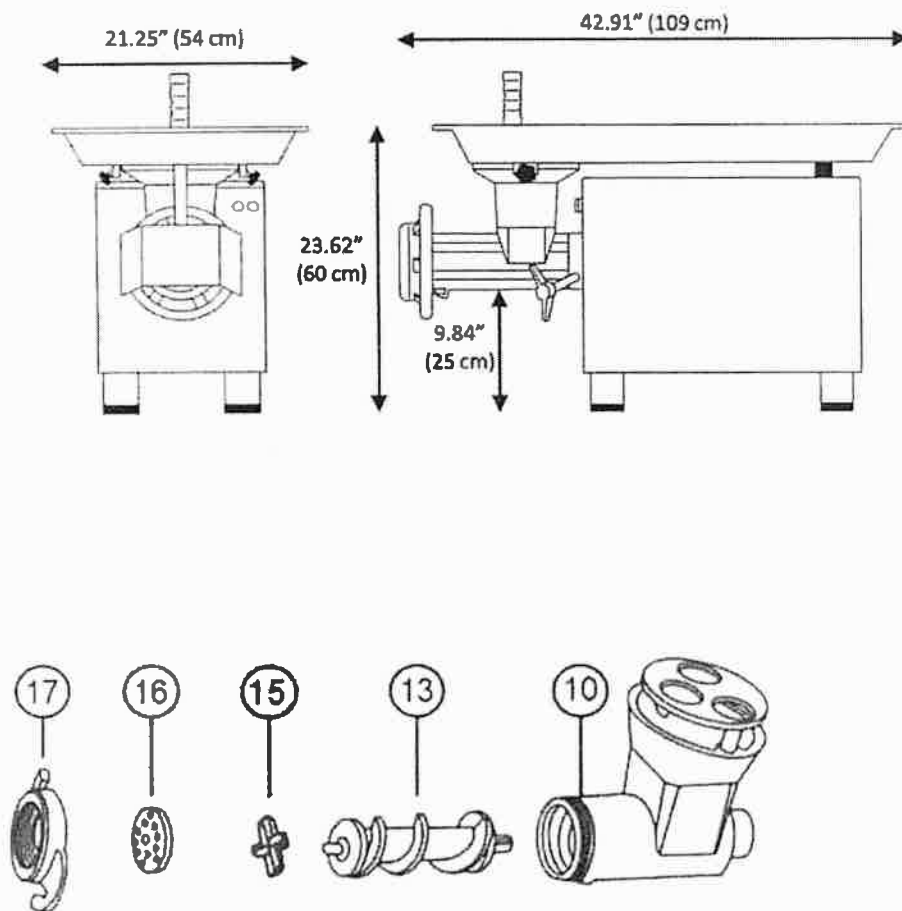
Figure 4. KG-32 Grinder.

The drawings below (Figure 4), are from the Pro-Cut owner's manual and give the scale of the machine and the components that go into the grinding head. The worm screw, marked as (13), is situated at the bottom of the vertical chute leading from the feed tray. This is the component that ultimately ingested Mr Husenov's hand and arm.

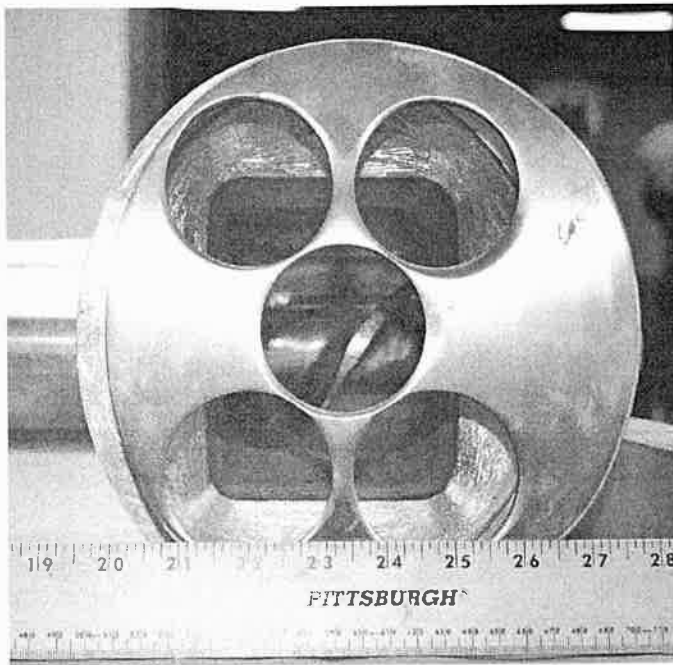
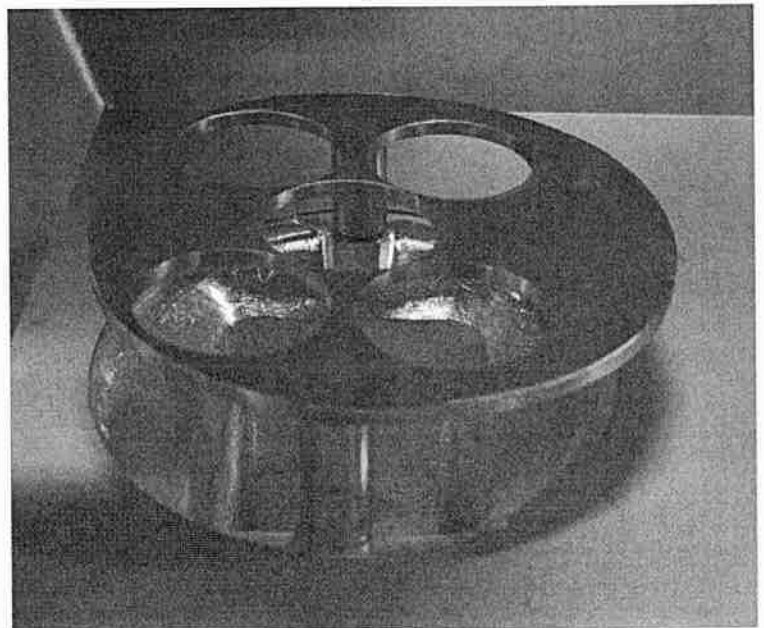
Figure 5. Safety guard.

The implication is therefore, that 3,300 lbs of meat product can in theory be pushed by a plastic pusher through a $2\frac{3}{8}$ inch hole in one hour. A top-down view of the guard can be seen in figure 5. The plastic pusher on its own and inserted into the guard is shown in figure 6.

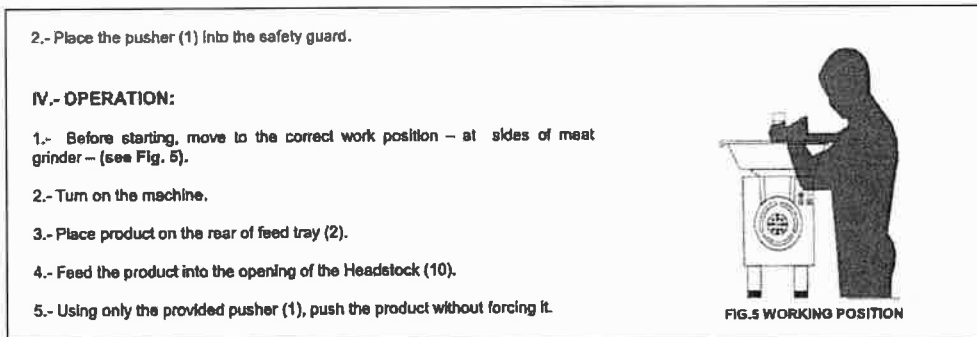
Figure 8. Operation section from Owner's Manual.

Also included under section (IV. Operation) is the following :-

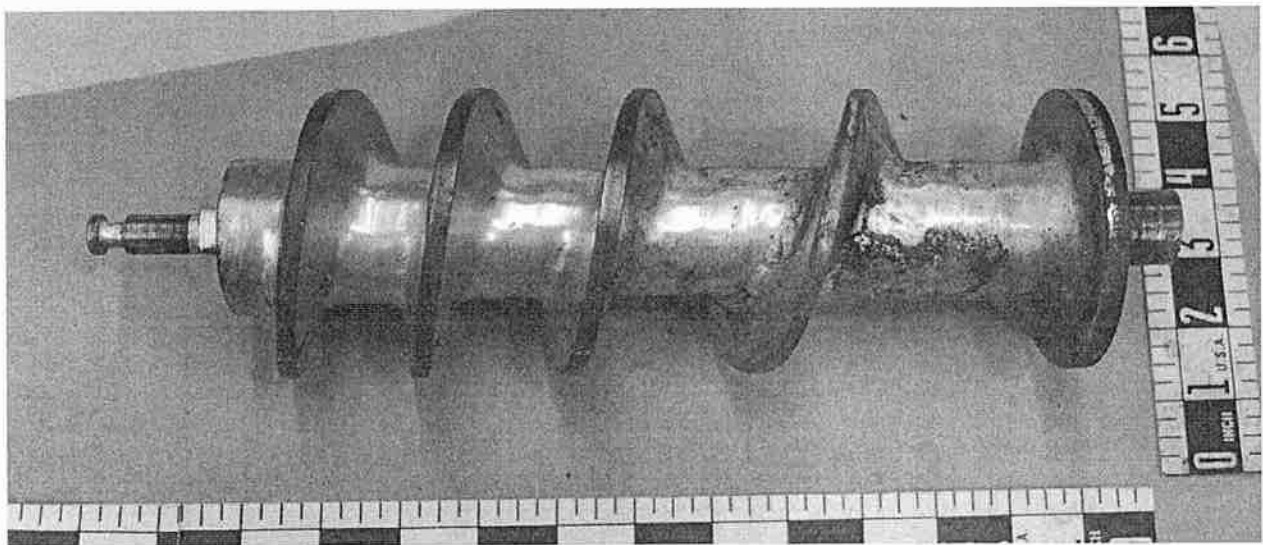
Figure 9. Worm Screw at bottom of vertical feed chute.

At no point, in either manual or brochure, is the specific danger of the worm screw (see figure 9) described to the operator. The one warning sign, (see figure 7), a type “supplemental directive” according to the American National Standards Institute (ANSI) standard ANSI Z535.6, appears to show an injury caused by a tool or blade and not by the worm screw.

- (i) WARNING signal words in the manual do not clearly state the danger posed by the grinder. Warning signs need to be replaced with DANGER signal words and a clear description that the worm screw WILL ingest and grind the user’s hand and arm if the user inserts his hand into the down chute causing catastrophic damage and/or death.

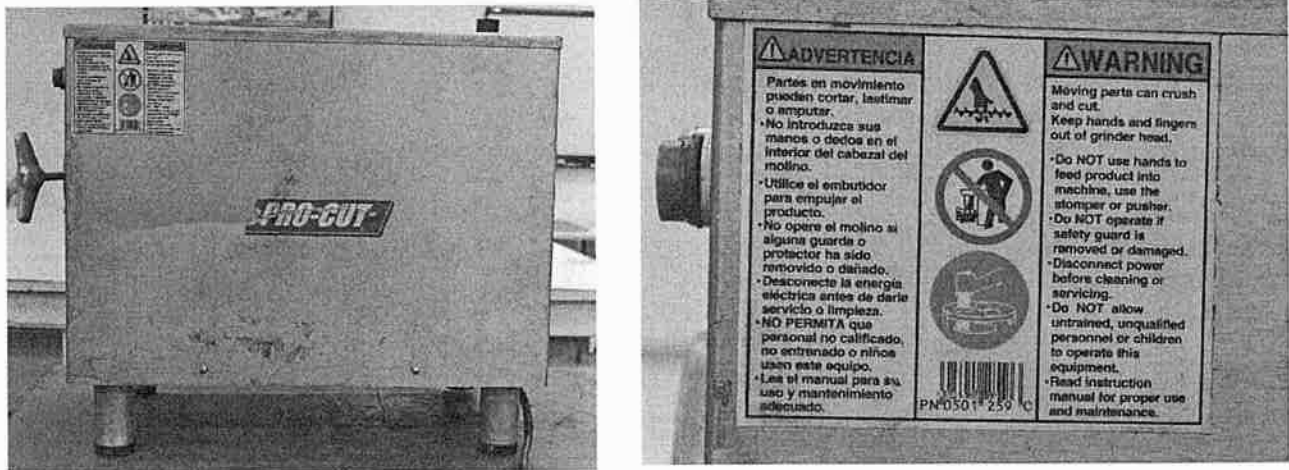
Figure 12. *WARNING Label on Grinder*

Figure 12, below shows the actual KG-32 power unit and the location of the machine's warning label, also shown is a close-up view of the label itself. As discussed in the previous section the WARNING label needs to be replaced by a DANGER label.

- (ii) The WARNING sign on the machine similarly needs to be replaced with a DANGER sign and placement of the sign needs to be enhanced such that the user can clearly see it when operating the machine. Adding it to heightened sides of the feed tray may be an option.

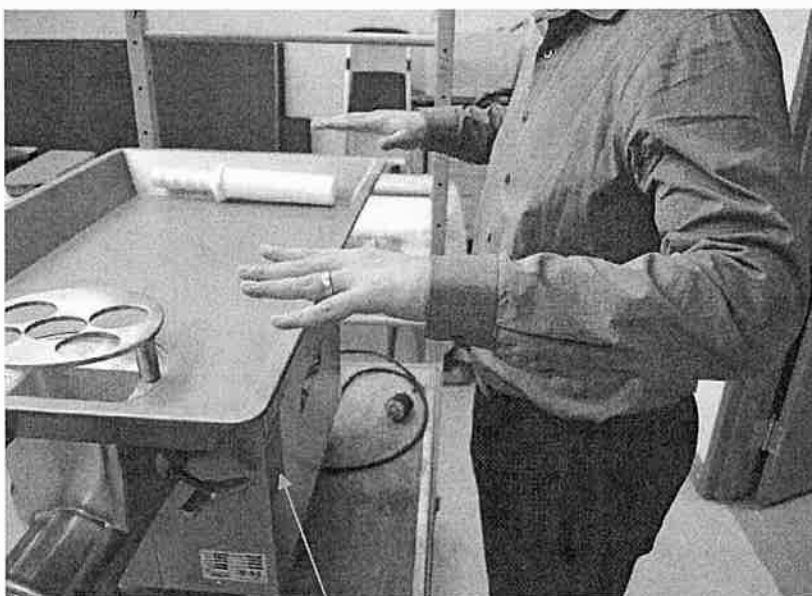
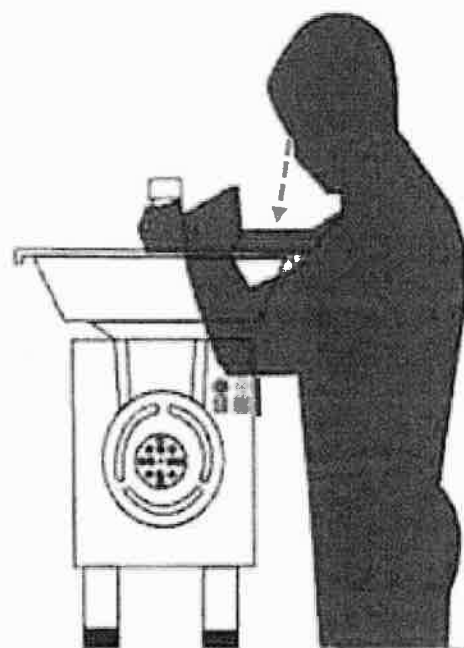
Figure 13. *WARNING Label not visible from operating position.*
(Right hand figure is from operator's manual)

Figure 13 also highlights another problem with the positioning of the label.

Working position as shown in ProCut user manual. Note tray is clearly blocking user's view of warning label and stop button.

Contrary to the ANSI Z535.4 standard the warning label is obscured from the operators view.

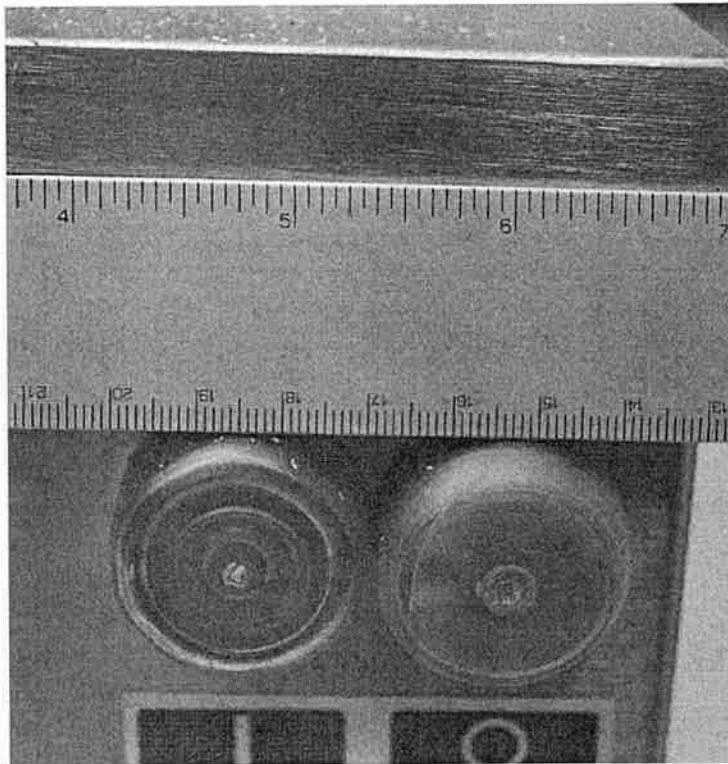
Figure 14. *Start and Stop buttons on the Pro-Cut KG-32*

The on and off buttons are shown in figure 14. There is only one regular stop button and no dedicated emergency stop button.

This is not to the International Organization for Standardization (ISO) standard. i.e. Per ISO 13850 Emergency Stop Function standard :-

The stop button on Pro-Cut KG-32 is approximately 25mm (1 inch) in diameter and is also somewhat recessed behind a plastic cover. A typical Emergency Stop button consists of a raised Red Mushroom type Button (Operator) that would, at its smallest size, still be of the order

- (iii) A bigger “mushroom head type” standard emergency stop button needs to be added to the machine in a location that is more accessible and can even be operated by the user’s body if an arm was to be trapped. i.e. Not on the side of the machine next to the worm screw. The current stop button **is not an emergency stop button**.

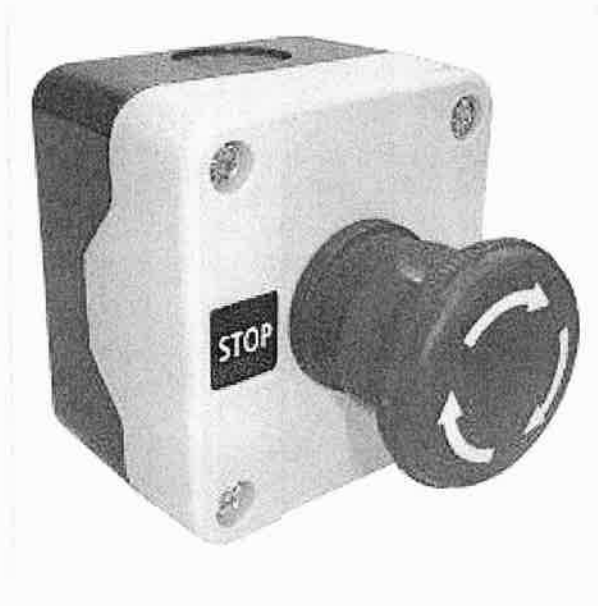
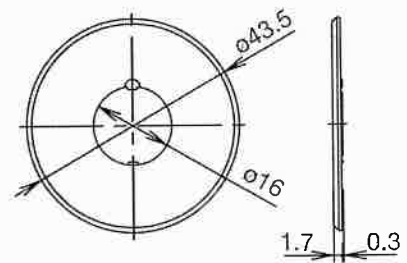
Figure 15. Typical E-Stop button with small button ISO 13850 Dimensions

of 30 mm in diameter with a 53.5 mm yellow back plate. (ISO 13850) i.e. Considerably bigger, See figure 15.

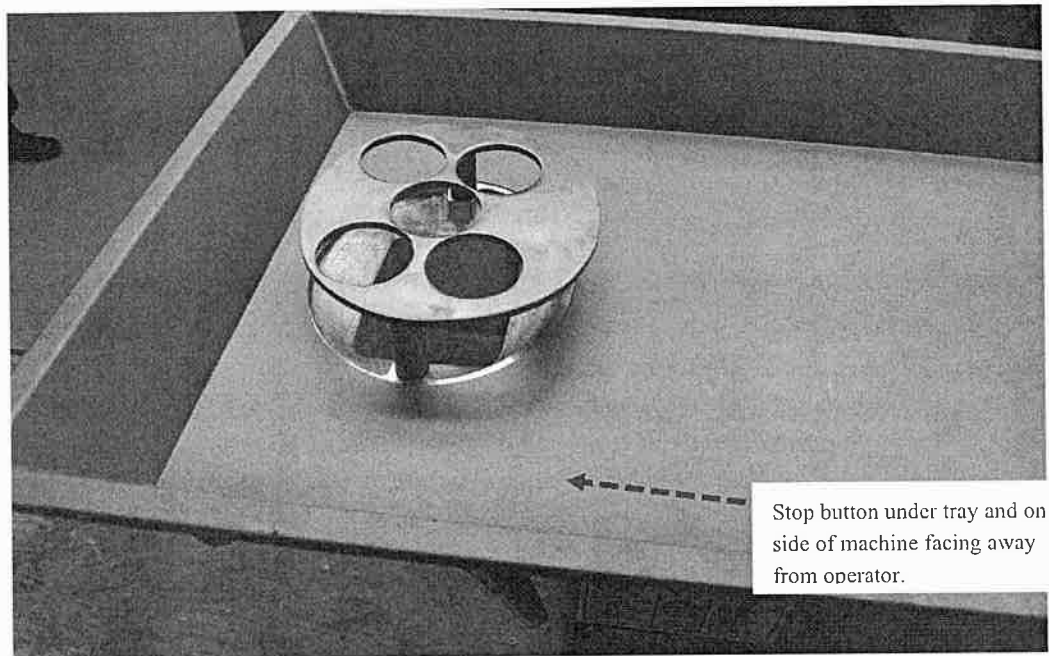
Figure 16. *Stop button not visible to operator or person rendering assistance to a trapped operator.*

In the previous section of this report the issue of visibility for the warning sign was discussed. For the stop button the situation is even worse. Apart from the feed tray obscuring the operator's view, the stop button is now located on the side of the machine. i.e. around a corner and oriented 90 degrees away from the operators forward view. The Stop button is therefore clearly not visible to the grinder operator. See figure 16. In an emergency, such as in this case, it would also be difficult for the user to reach the button if either of his/her hands was ingested into the worm screw. As the operator would also be effectively blocking access to the Stop button it would also be difficult for someone rendering assistance to also stop the machine.

Clearly from figure 16 it can be seen that when operating the grinder the user will not be able to see the stop button and as such it is clearly placed in the wrong position.

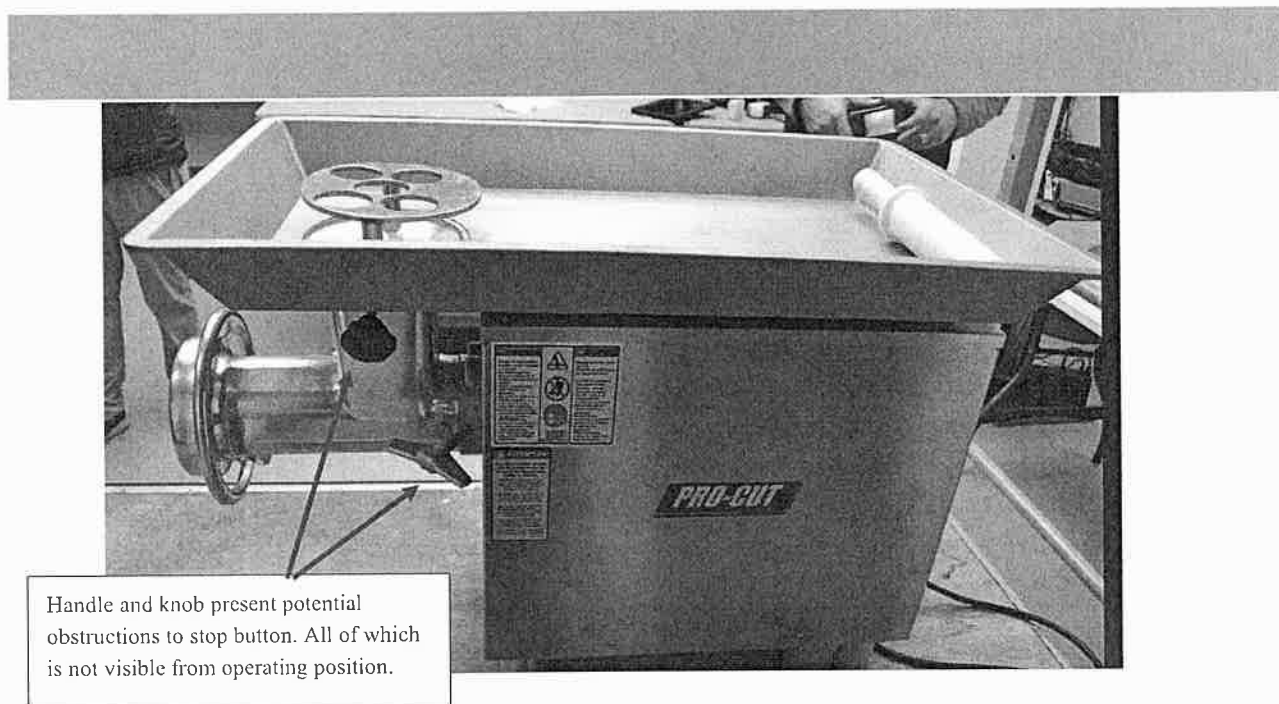
Figure 17. Possible obstructions to access of STOP button

Also of concern, and shown in figure 17, is the potential obstruction to the stop button presented by the tray locking knob and the head attachment handle. Of interest is the fact that on another Pro-Cut grinder model, KG-12 the tray locking knob has been removed and only a grinder head locking knob remains. For the remaining single tray locking knob there are two versions with different locations (see figure 18 (a) and (b)). In the KG-12_SS model the “handle” comes off the grinder head horizontally and so approaches the location of the stop button. In the KG-12-FS version the knob comes off the grinder head in downward direction and so moves away from the stop button/switch. There seems no reason for this change other than a recognition of the possible obstruction issue.

- (iv) The location of the stop button should not be impaired by obstructions and protrusions such as the grinder head locking handle and the feed tray locking knob. Both of which are in close proximity to the stop button on this machine. Other grinders provided by this same manufacturer have removed these obstructions.

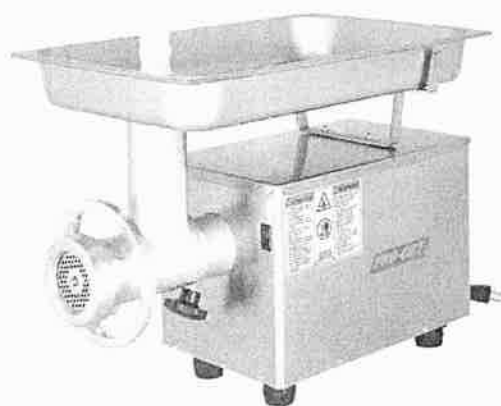
Figure 18 (a) ProCut KG-12-FS Electric Meat Grinder 115V, ¼ HP

Note that other manufacturers of similar Meat Grinders have made a much better attempt at installing a “proper emergency stop button” and have done so at the front of the machine where it can be seen and more easily accessed. (Figure 19(a) and (b).) Of note is that it would also be possible for an operator with a trapped hand to bump the Emergency stop button with his body when it is placed on the front.

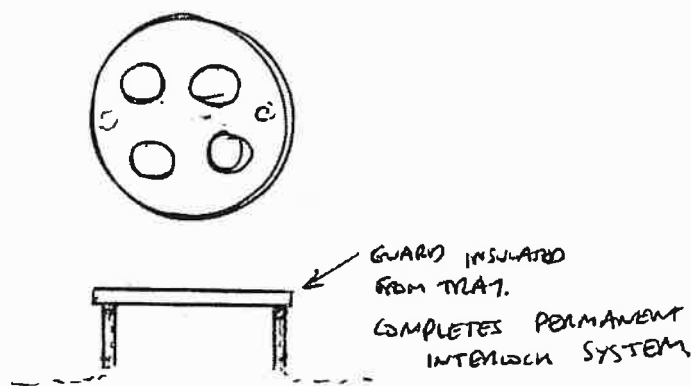
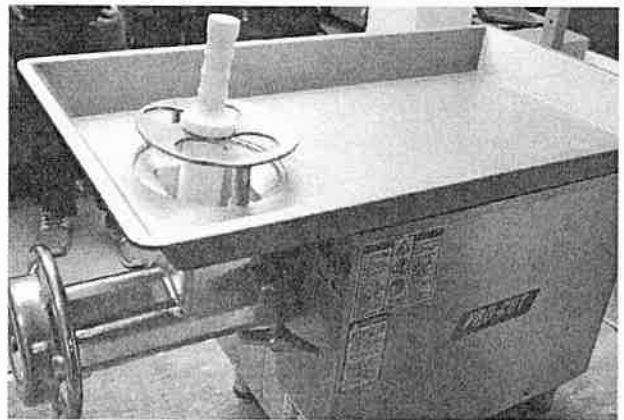
Figure 20. Sketch of possible interlock on guard along with photograph.

As the potential removal of the guard is foreseeable (per UL73 19.1A) it would seem prudent to install an interlock system. Using the guard circular disk to complete an interlock low voltage circuit would not significantly impact the design and would render operation of the grinder without the guard not possible. See sketch and photograph below.(Figure 20)

Utilizing the stainless steel guard itself as the “interlock switch” would seem to accommodate UL 73 , 33.9.

- (v) As a practical matter, to obtain the high meat processing rates advertised for this machine it is not realistic to expect an operator to be constantly removing and inserting the plastic pusher into the guard in order to move the meat horizontally across the tray and then vertically down the chute. As such, this system needs to be improved. In the interim, recognition of the fact that users will remove the guard needs to be made. (Per UL 73 19.1A) and as such an interlock that would prevent operation of the grinder without the guard is required.
